2010 MAZDA 6/Atenza Wagon OEM Service and Repair Workshop Manual

ENGINE OIL PRESSURE SENSOR INSPECTION [SKYACTIV-D 2.2]

ACCELERATOR PEDAL POSITION (APP) SENSOR REMOVAL/INSTALLATION [SKYACTIV-D 2.2]

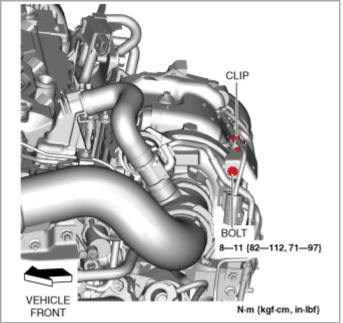
ac5uuw00008559

9.Remove the clip.

10.Remove the A/F sensor using the SST.

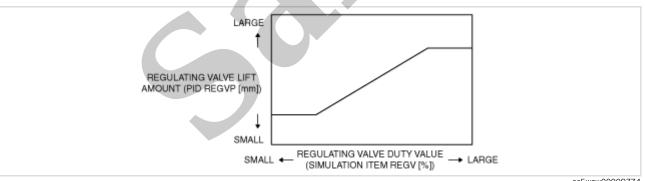
ac5wzw00009774

Specification (Reference)

- The regulating valve position sensor is integrated in the regulating valve actuator. The regulating valve actuator is integrated in the turbocharger.
- 1.Connect the M-MDS to the DLC-2.
- 2. Switch the ignition ON (engine running).
- 3.Access the PID/DATA monitor item REGVP and simulation item REGV using the M-MDS. (See ON-BOARD DIAGNOSTIC TEST [PCM (SKYACTIV-D 2.2)].)
- 4. Verify that the PID/DATA monitor item REGVP changes according to the regulating valve opening angle when the simulation item REGV is set from 0 % to 95 %.
 - If not as verified, replace the turbocharger. (See TURBOCHARGER REMOVAL/INSTALLATION [SKYACTIV-D 2.2].)
