2018 MAZDA 3 / Axela Hatchback OEM Service and Repair Workshop Manual

REAR SEAT CUSHION REMOVAL/INSTALLATION

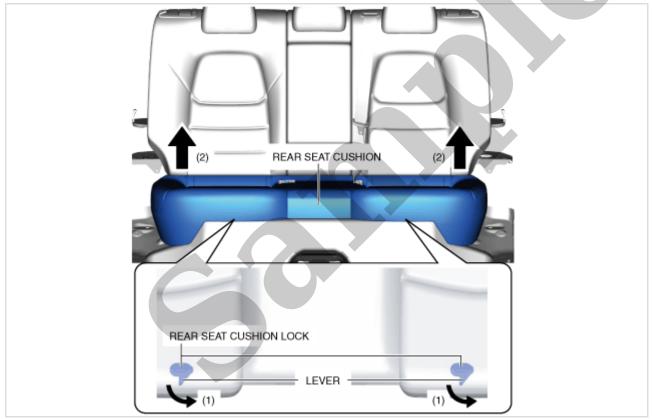
atrkjt00000112

- When performing the procedure with a rear seat cushion removed from the vehicle, perform the procedure on a clean cloth so as not to damage or dirty the seat.
- 1.Disconnect the negative battery terminal and wait for 1 min or more. (With rear seat warmer system) (See NEGATIVE BATTERY TERMINAL DISCONNECTION/CONNECTION.)
- 2. While moving the rear seat cushion lock levers in the direction of arrows (1) shown in the figure, lift up the rear seat cushion in the direction of arrows (2) and detach the rear seat cushion from the rear seat cushion lock.

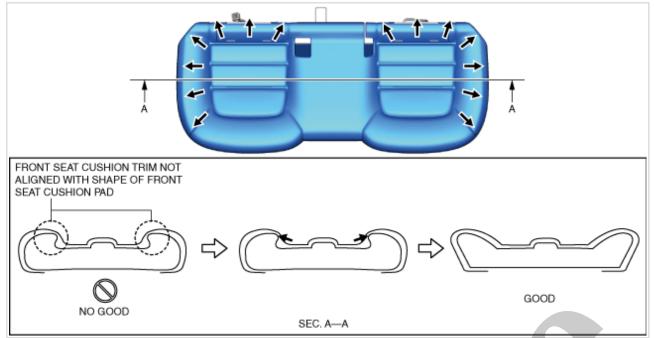
ac5uuw00011034

1. Align the rear seat cushion trim with the installation hole of the rear seat cushion pad, and install the C-rings.

- If a C-ring is damaged while removing or installing the rear seat cushion trim and rear seat cushion pad, it may not be possible to install the rear seat cushion trim and rear seat cushion pad normally. When removing or installing the rear seat cushion trim and rear seat cushion pad, be careful not to damage the C-rings.
- If a C-ring is damaged, replace it with a new one.

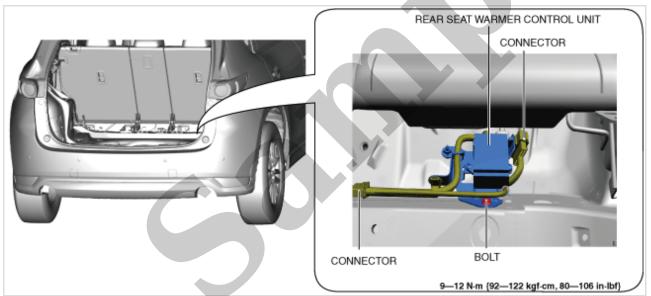
ac5uuw00011901

- 1.Disconnect the negative battery terminal and wait for 1 min or more. (See NEGATIVE BATTERY TERMINAL DISCONNECTION/CONNECTION.)
- 2.Fold the rear seat back.
- 3. Remove the trunk boad. (See TRUNK BOARD REMOVAL/INSTALLATION.)
- 4.Remove the sub-trunk. (See SUB-TRUNK REMOVAL/INSTALLATION)
- 5. Disconnect the rear seat warmer control unit connector.

- 6.Remove the bolt.
- 7. Remove the rear seat warmer control unit.
- 8.Install in the reverse order of removal.
