## 2018 VOLVO V90 Cross Country OEM Service and Repair Workshop Manual

## STOP BUTTON SEAT BELT > STOP BUTTON SEAT BELT [2018-2022] > INSTALLATION

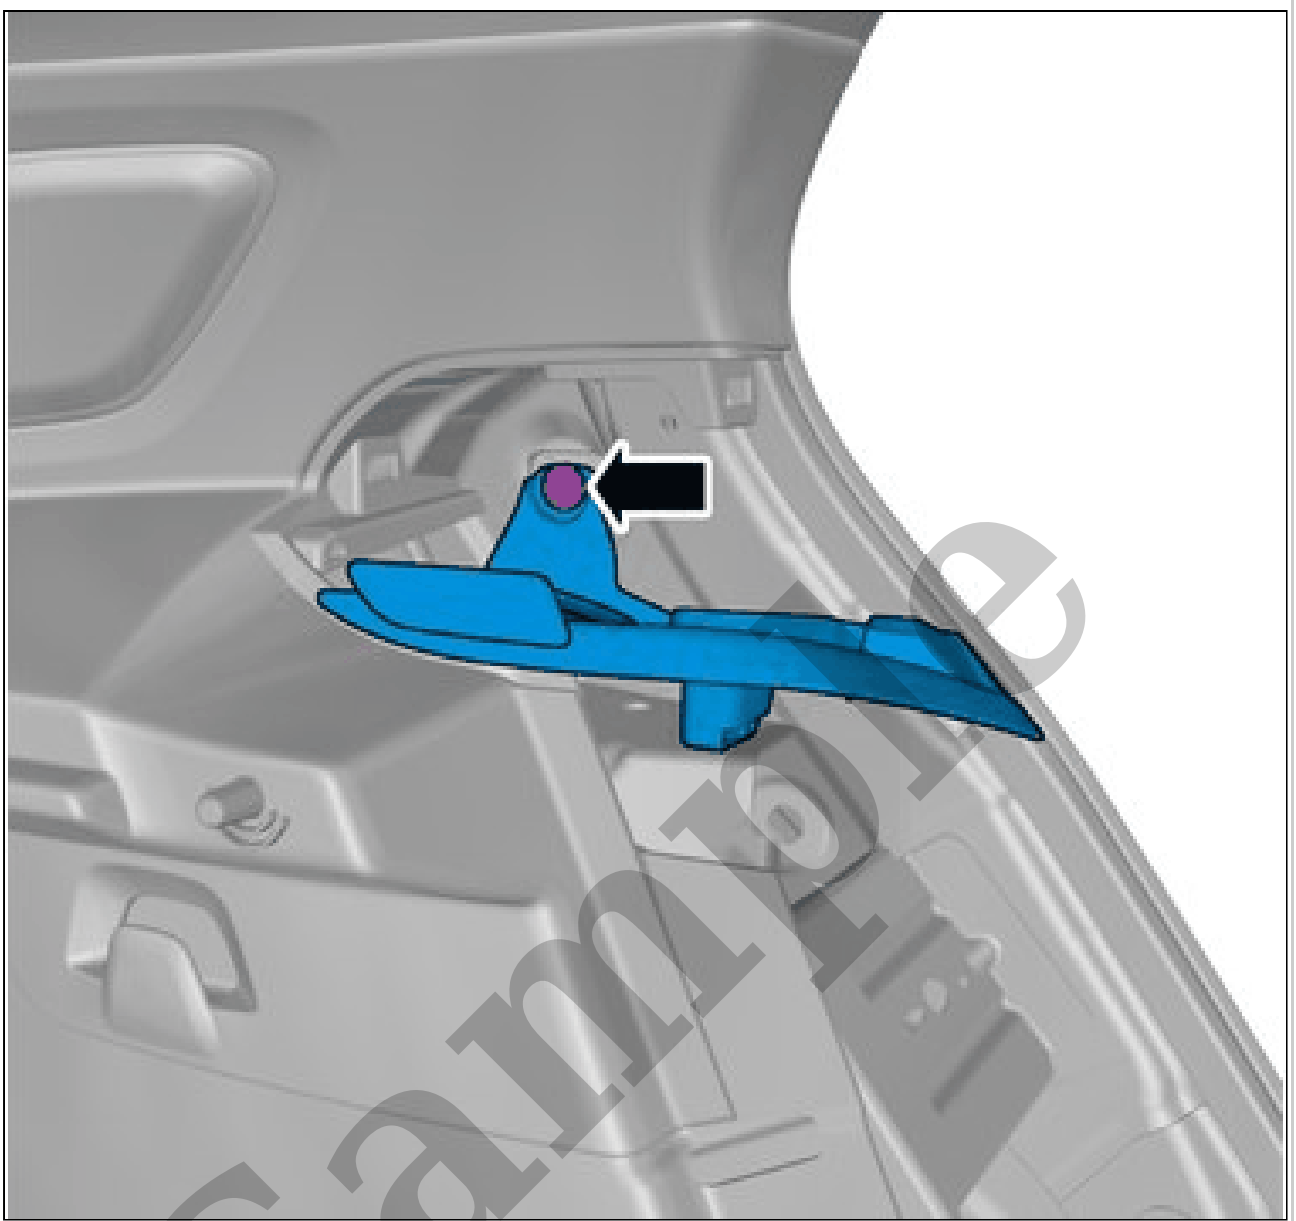
Remove the screw.

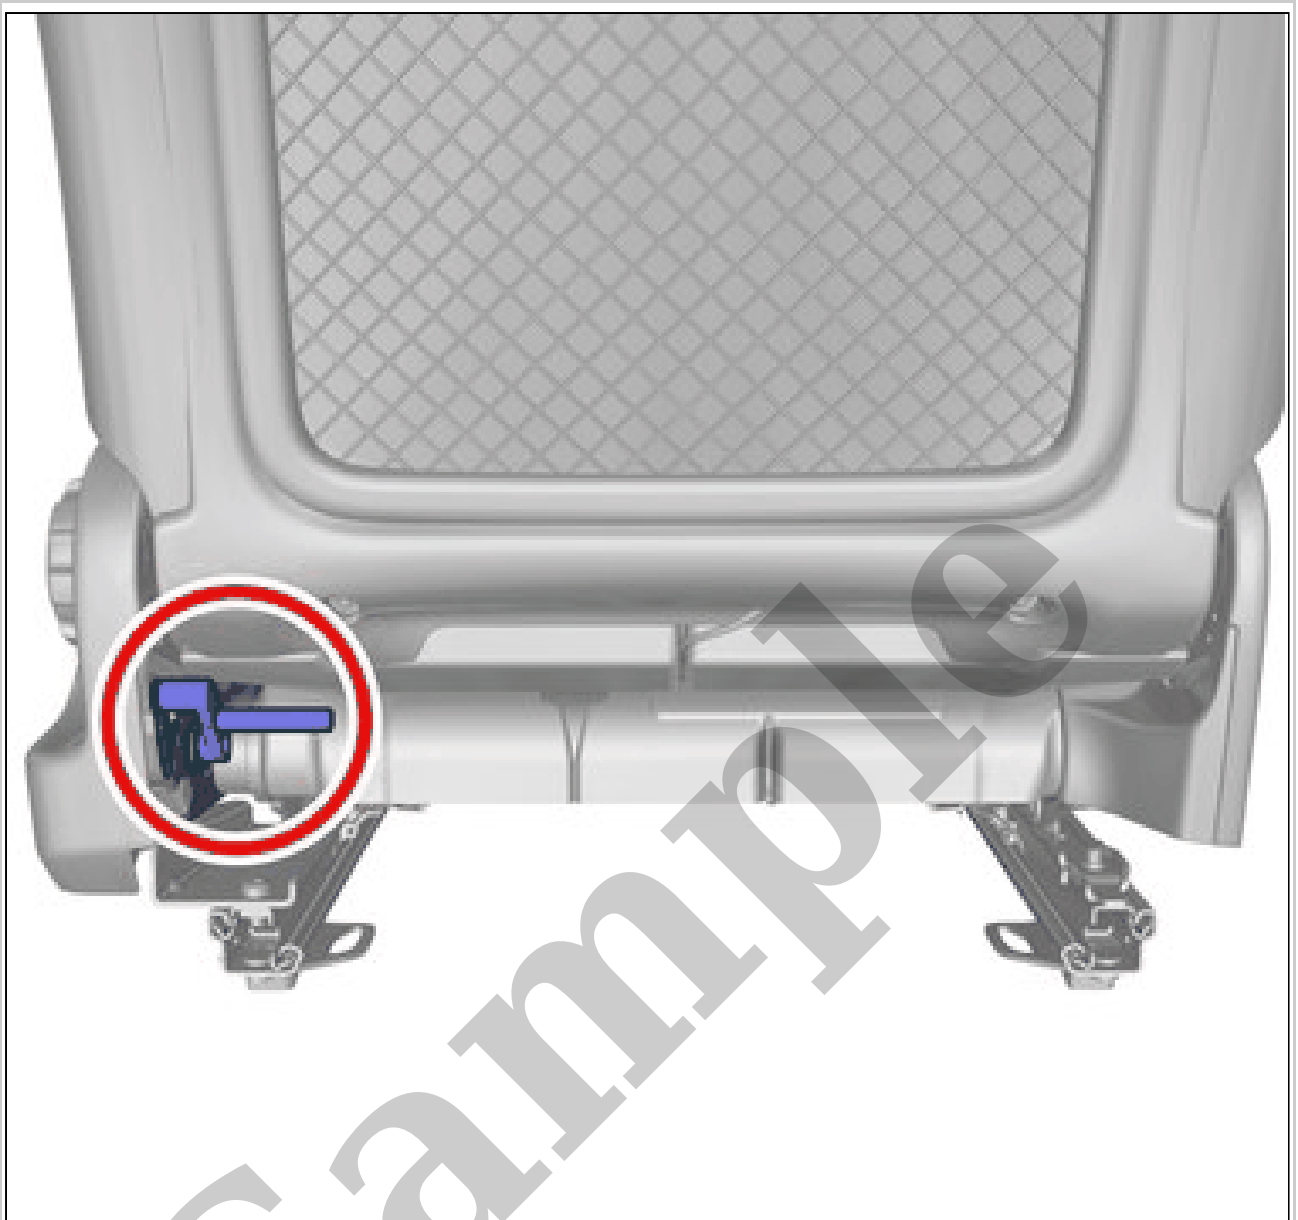
**NOTE:** *Orientation view*
