2022 Toyota RAV4 Prime Service and Repair Manual

Last Modified: 07-26-2024	6.11:8.1.0	Doc ID: RM100000001R9LE
Model Year Start: 2021	Model: Supra	Prod Date Range: [07/2020 -]
Title: SUPPLEMENTAL RESTRAINT SYSTEMS: SPIRAL CABLE: REMOVAL; 2021 - 2025 MY Supra [07/2020 -]

Last Modified: 07-26-2024	6.11:8.1.0	Doc ID: RM100000001JCIU
Model Year Start: 2020	Model: Supra	Prod Date Range: [03/2019 -]
Title: SUPPLEMENTAL RESTRAINT SYSTEMS: SPIRAL CABLE: INSPECTION; 2020 - 2025 MY Supra [03/2019 -]

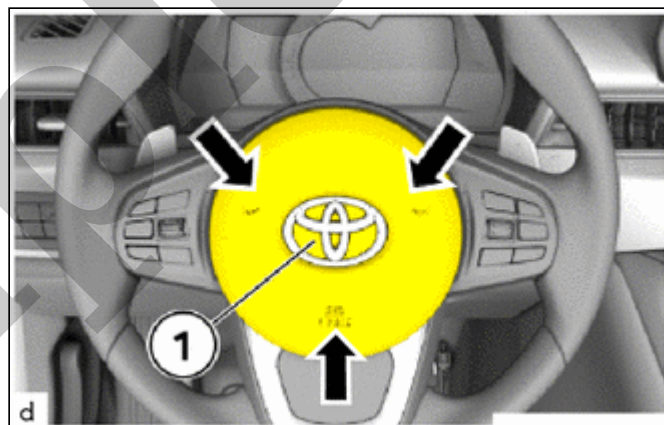
2. CONNECT CABLE TO NEGATIVE BATTERY TERMINAL

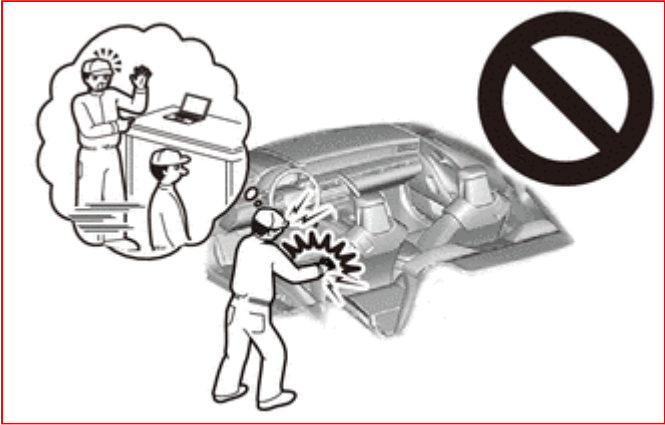
Danger! Life-threatening injuries!

- Before performing any work on the airbag, always disconnect the battery earth lead from the battery.
- Airbag unit may only be set down with the cushion (airbag itself) facing upwards.

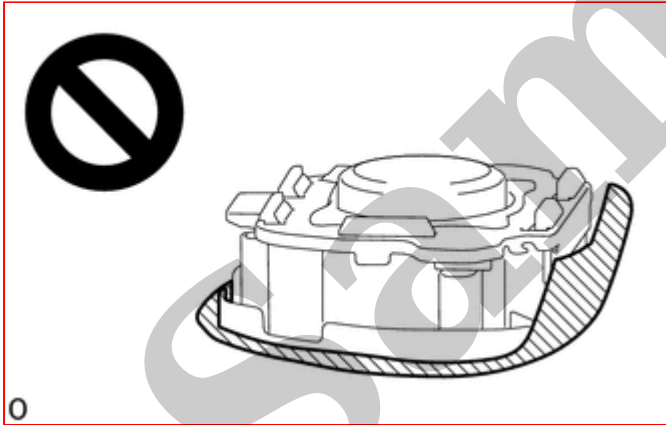
- All work on pyrotechnic parts may be carried out by technically experienced and appropriately trained personnel only.
- Replace any damaged part or ones that have been dropped.
- For additional information see:
