## 2023 Jeep Renegade Service and Repair Manual

## MOTOR-VENT-SEAT BACK-LEFT REAR

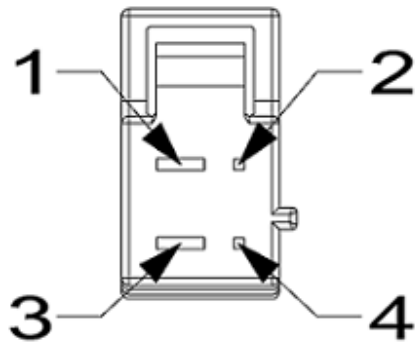
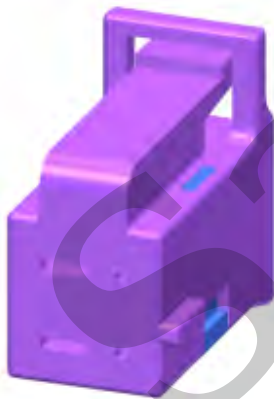
## Connector Views

Isometric View:

Wire Insertion Side:

| Pin | Cicuit | Cicuit Function | Color | Gauge/Size | Option |
| HEADLINER_SUNROOF | | | | | |
| 1 | Q556 | OPEN SIGNAL | VT | 2.0 | |
| 2 | Q958 | HALL EFFECT SIGNAL | GN | 0.50 | |
| 3 | Q959 | SENSOR RETURN | GY | 0.50 | |
| 4 | Q56 | CLOSE SIGNAL | BK | 2.0 | |
| 5 | Q957 | 5 VOLT SUPPLY | BU | 0.50 | |

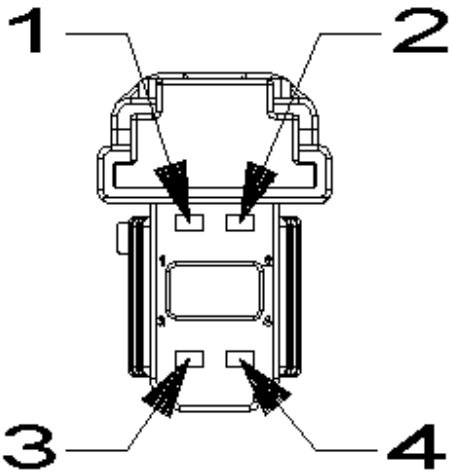
Connector Views

| Pin | Cicuit | Cicuit Function | Color | Gauge/Size | Option |
| SEAT_BACK_PASSENGER | | | | | |
| 1 | P230 | POWER SUPPLY | GN | 0.35 | |
| 3 | P859 | PWM CONTROL | GY | 0.35 | |
| 4 | Z920 | GROUND | BK | 0.35 | |

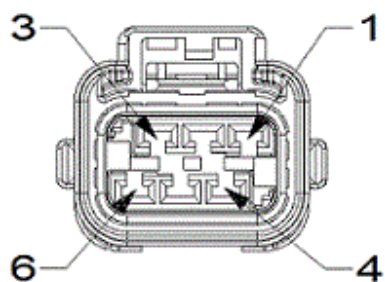
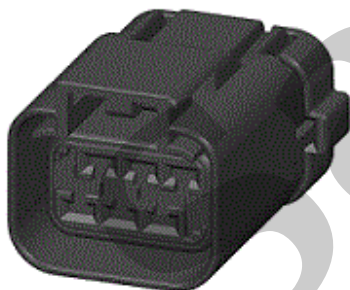
## Connector Views

Isometric View:

Wire Insertion Side:

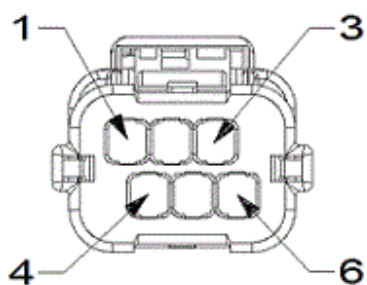
## Connector Views

| Pin | Circuit | Circuit Function | Color | Gauge/Size | Option |
| DOOR_PASSENGER | | | | | |
| 1 | Q12 | MOTOR (UP) | OG | 2.0 | RHD |
| 1 | Q22 | MOTOR (DOWN) | OG | 2.0 | LHD |
| 2 | N0 | NO CONNECT | NA | 0 | |
| 3 | Q12 | MOTOR (UP) | OG | 2.0 | LHD |
| 3 | Q22 | MOTOR (DOWN) | OG | 2.0 | RHD |
| 4 | Q990 | SENSOR RETURN | BK | 0.50 | |
| 5 | Q306 | POWER SUPPLY | OG | 0.50 | |
| 6 | Q302 | HALL EFFECT SIGNAL | OG | 0.50 | |
