2023 NISSAN Z Nismo Service and Repair Manual

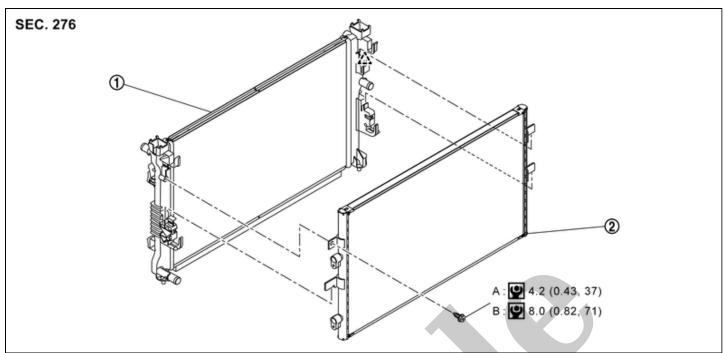
RDE-001931241-01-000376576

1	Radiator	2	Condenser	
Δ	: Pawl			
A	: When not replaced the radiator			
В	: When replaced the radiator			
9	: N•m (kg-m, in-lb)

Perform lubricant return operation before each refrigeration system disassembly. However, if a large amount of refrigerant or lubricant leak is detected, never perform lubricant return operation. Refer to Perform Lubricant Return Operation.

- 1 Use a refrigerant collecting equipment (for HFO-1234yf) to discharge the refrigerant. Refer to Recycle Refrigerant.
- 2 Remove accumulator assembly. Refer to Removal & Installation.
- 3 Remove cooler pipe A. Refer to Removal & Installation.
- 4 Remove cooler pipe B. Refer to Removal & Installation.
- 5 Remove cooling fan. Refer to COOLING FAN: Removal & Installation.
- 6 Remove condenser fixing screw (A).

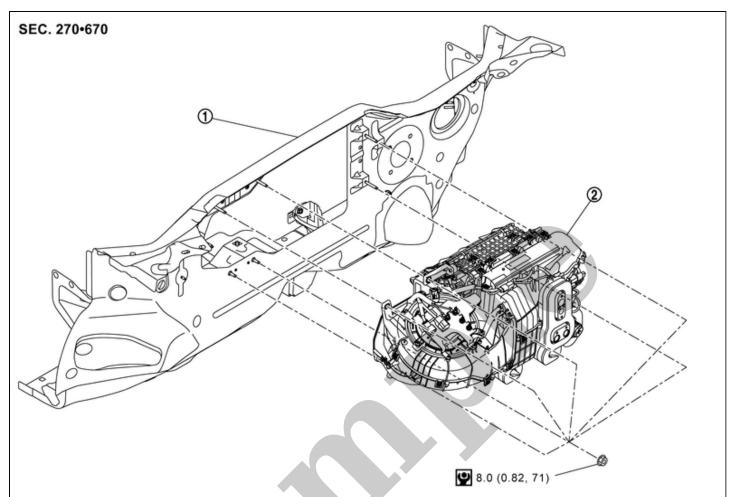
RDE-001931246-01-000376598

1	Lower dash assembly	2	A/C unit assembly	
•	: N•m (kg-m, in-lb)

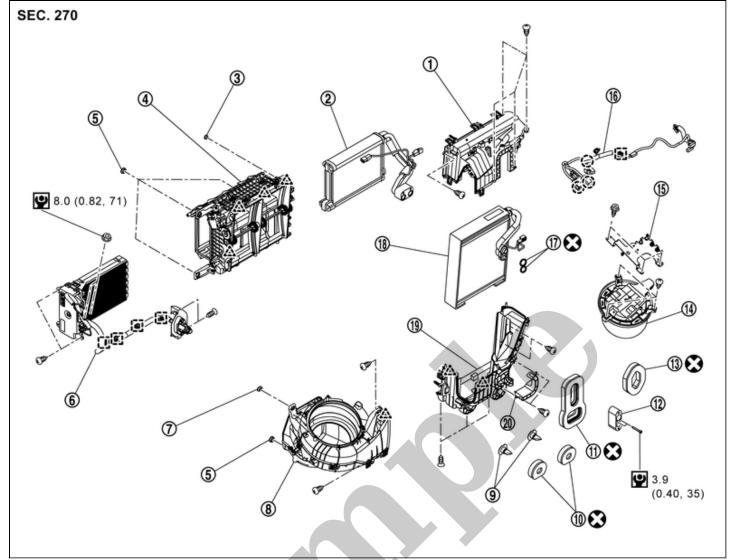
RDE-001931246-02-000376599

1	Front case upper	@	Inner condenser	3	Collar 1		
4	Rear case	(5)	Collar 2	6	PTC heater		
7	Collar 3	8	Blower case	9	Drain hose		
10	Drain seal	1	Pipe seal	12	Evaporator connector		
13	PTC seal	4	Blower motor	15)	Sub harness bracket		
16	Sub harness	(O-ring	18	Evaporator		
19	Front case lower		Pipe cover				
$\langle \rangle$: Clip						
[]	: Metal clip						
8	: Always replace after every disassembly.						
•	: N•m (kg-m, in-lb)

- 1 Remove blower case assembly and PTC heater harness from A/C unit case assembly referring to PTC heater removal procedure 1 to 4. Refer to Removal & Installation.
- 2 Remove inner condenser. Refer to Removal & Installation.
- 3 Disconnect intake sensor harness connector.
- 4 Remove intake sensor harness connector from front case upper.
- 5 Disengage sub harness fixing clip (A).
