2003 FORD Mustang OEM Service and Repair Workshop Manual

PINPOINT TEST Y : THE VEHICLE WI-FI HOTSPOT FEATURE IS INOPERATIVE, EXPERIENCING POOR DATA SPEED OR CANNOT STREAM ANY DATA

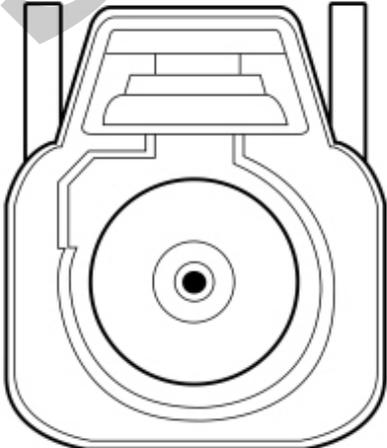
<p>E316038</p>	\bar{V}	Ground

- Ignition OFF.
- Connect the primary cellular antenna cable to the TCU (telematic control unit module) .
- Disconnect primary cellular antenna cable from the GPS (global positioning system) /satellite radio/cellular antenna.
- Ignition ON.
- Measure:

Positive Lead	Measurement / Action	Negative Lead

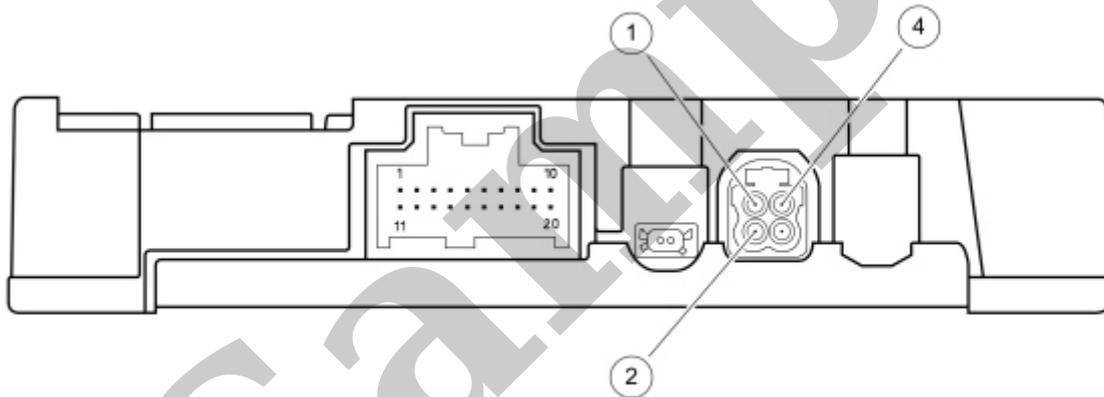
E332863

TCU (telematic control unit module) Antenna Cable Connections

Item	Part Number	Description
1	—	Secondary cellular antenna connection
2	—	GPS antenna connection
4	—	Primary cellular antenna connection
