## 2004 CHEVROLET Uplander OEM Service and Repair Workshop Manual

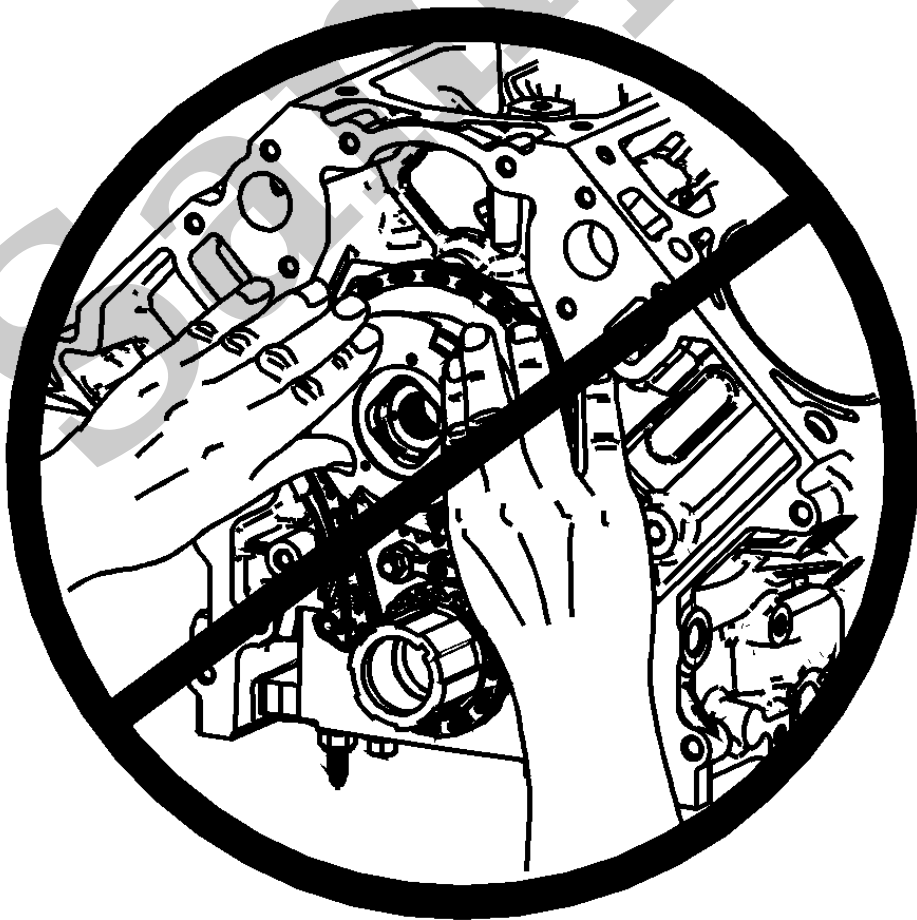
This vehicle is equipped with torque-to-yield or single use fasteners. Install a NEW torque-to-yield or single use fastener when installing this component. Failure to replace the torque-to-yield or single use fastener could cause damage to the vehicle or component.

Install a NEW CMP actuator solenoid valve (1). With the CMP actuator properly positioned onto the camshaft, the CMP actuator solenoid valve can be threaded completely into the camshaft using light hand pressure. Tighten by hand until snug.

1. Tighten a first pass to **65 N·m (48 lb ft)** .
2. Tighten a final pass an additional **90 degrees** using **EN-45059 angle meter** .
