2019 Ford Police Interceptor Utility Service and Repair Manual

303-14B Electronic Engine Controls - 3.3L Duratec-V6	2022 F-150
Removal and Installation	Procedure revision date: 05/28/2020

Camshaft Position (CMP) Sensor

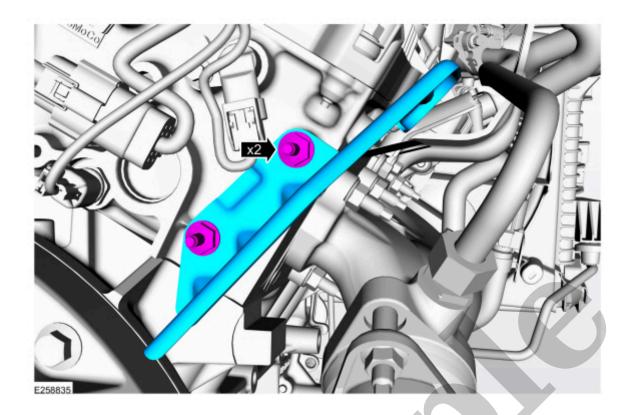
- 1. Remove the RH (right-hand) fender splash shield. Refer to: Fender Splash Shield
- 2. Disconnect the transmission wiring harness retainers from the stud bolts.

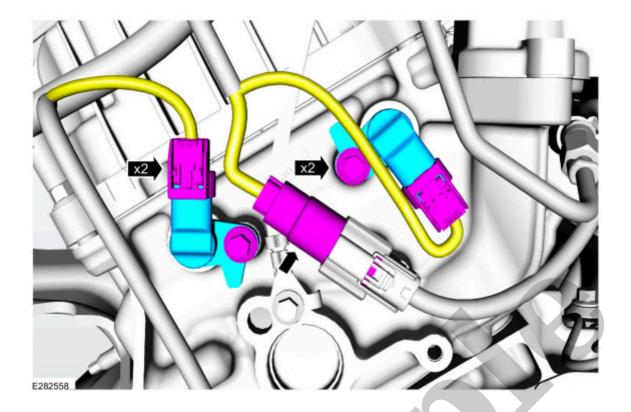
4. • Disconnect the CMP (camshaft position) sensor electrical connector and remove the retainer and the CMP (camshaft position) sensor.

Torque: 89 lb.in (10 Nm)

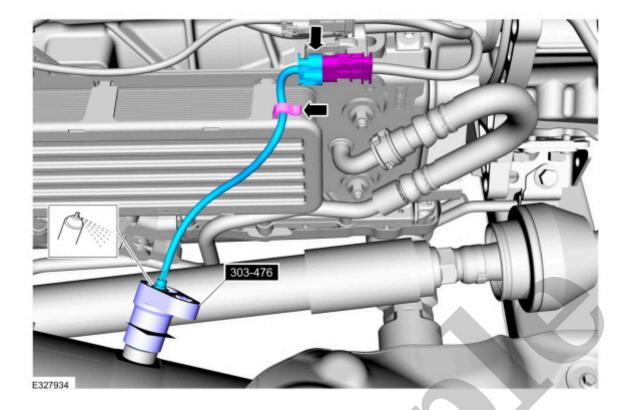
- 3. Disconnect the electrical connector and remove the harness retainer.
 - Apply penetrating oil to sensor, using the special tool remove the Catalyst monitor sensor.

Use Special Service Tool: 303-476 (T94P-9472-A) Socket, Exhaust Gas Oxygen Sensor **Material**: Motorcraft® Penetrating and Lock Lubricant / XL-1

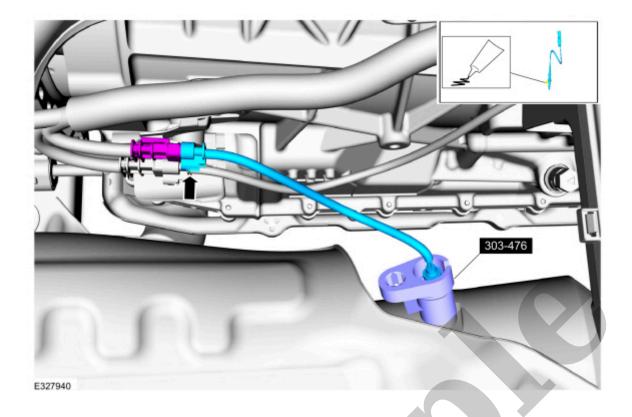
1. • Apply anti-seize to thread of sensor, using special tool install the Catalyst monitor sensor.

Use Special Service Tool: 303-476 (T94P-9472-A) Socket, Exhaust Gas Oxygen Sensor

Material: Motorcraft® High Temperature Nickel Anti-Seize Lubricant / XL-2

Torque: 35 lb.ft (48 Nm)

• Install the harness retainer and connect the electrical connector.

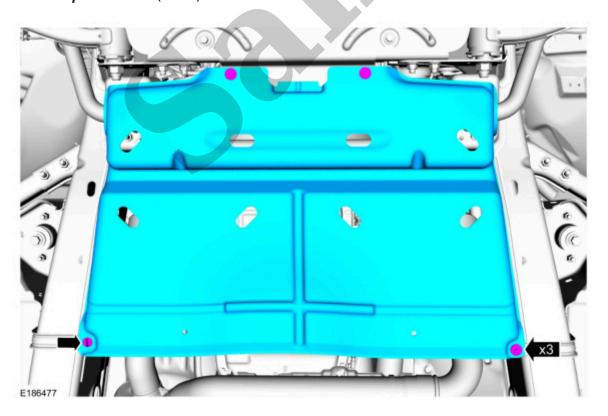
3. If equipped, install the underbody shield.

Torque: 71 lb.in (8 Nm)

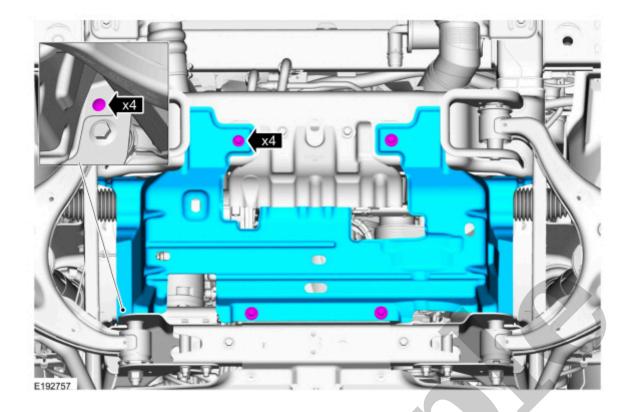
- 2. If equipped, remove the bolts.
 - Release the retainer and remove the transmission housing cover.

Torque: 71 lb.in (8 Nm)
