2024 Lexus ES 350 Service and Repair Manual

Last Modified: 10-07-2024	6.11:8.1.0	Doc ID: RM100000002H6MI
Model Year Start: 2024	Model: GX550	Prod Date Range: [12/2023 -]
Title: PARK ASSIST / MONITORING: MULTI-TERRAIN MONITOR SYSTEM: U011487; Lost Communication with Four-Wheel Drive Clutch Control Module Missing Message; 2024 MY GX550 [12/2023 -]

Last Modified: 10-07-2024	6.11:8.1.0	Doc ID: RM100000002H6MK
Model Year Start: 2024	Model: GX550	Prod Date Range: [12/2023 -]
Title: PARK ASSIST / MONITORING: MULTI-TERRAIN MONITOR SYSTEM: ECU Power Source Circuit; 2024 MY GX550 [12/2023 -]

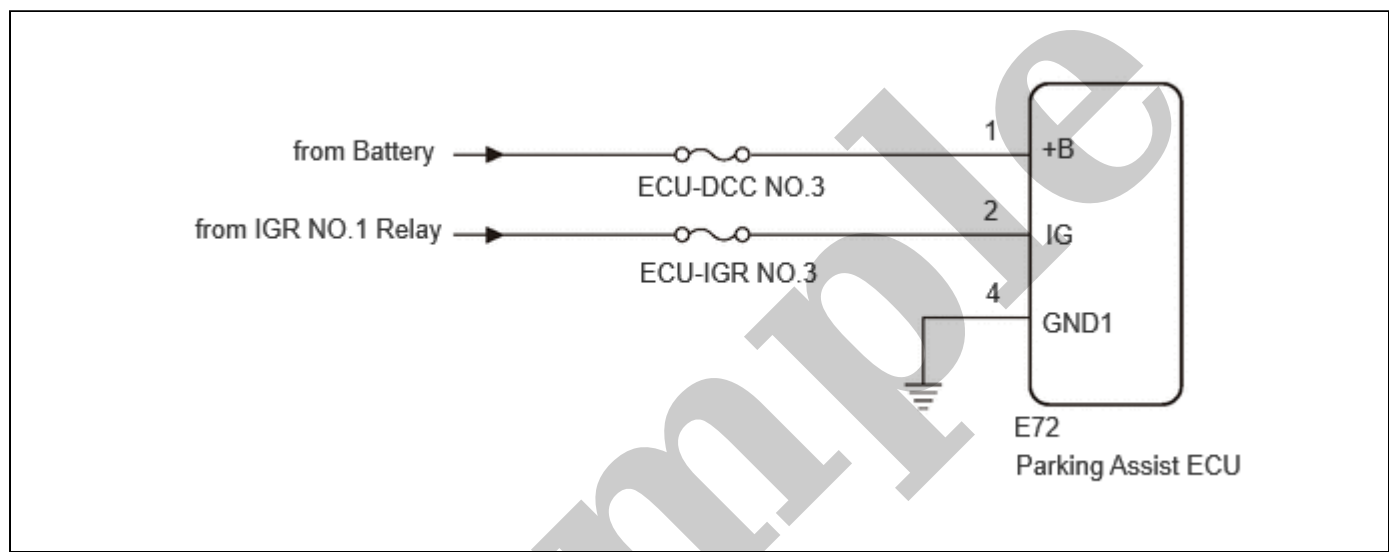
WIRING DIAGRAM

This circuit is the power source circuit to operate the parking assist ECU. The parking assist ECU controls the multi-terrain monitor system.

ECU Power Source Circuit
