1993 CHEVROLET Tahoe 3 doors OEM Service and Repair Workshop Manual

Horn Replacement

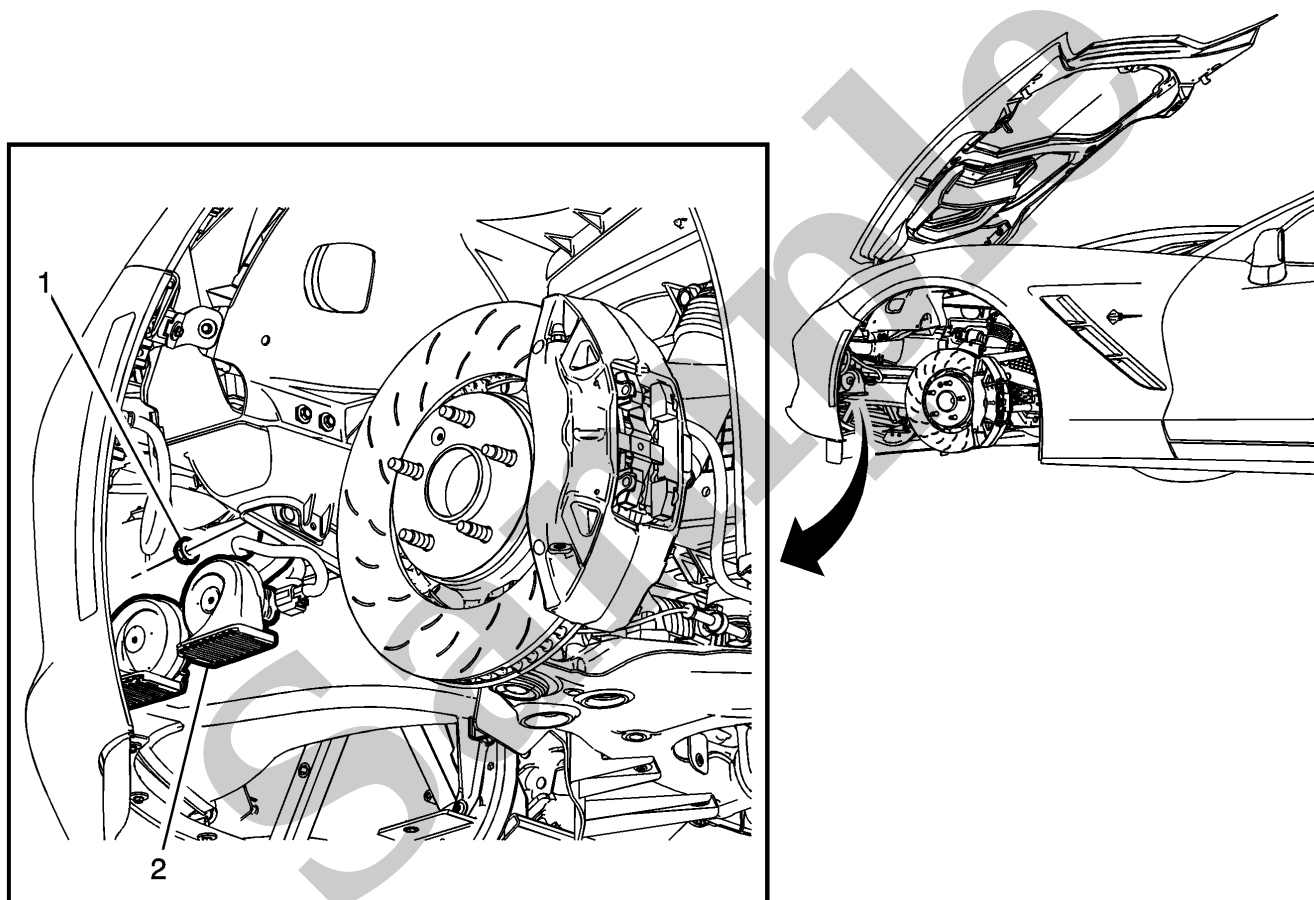
Horn Replacement

Callout	Component Name
Preliminary Procedure Remove the left front wheelhouse liner. Refer to Front Wheelhouse Liner Replacement .	
1	Horn Nut
