1995 CHEVROLET Cavalier OEM Service and Repair Workshop Manual

Instrument Panel Knee Bolster Replacement

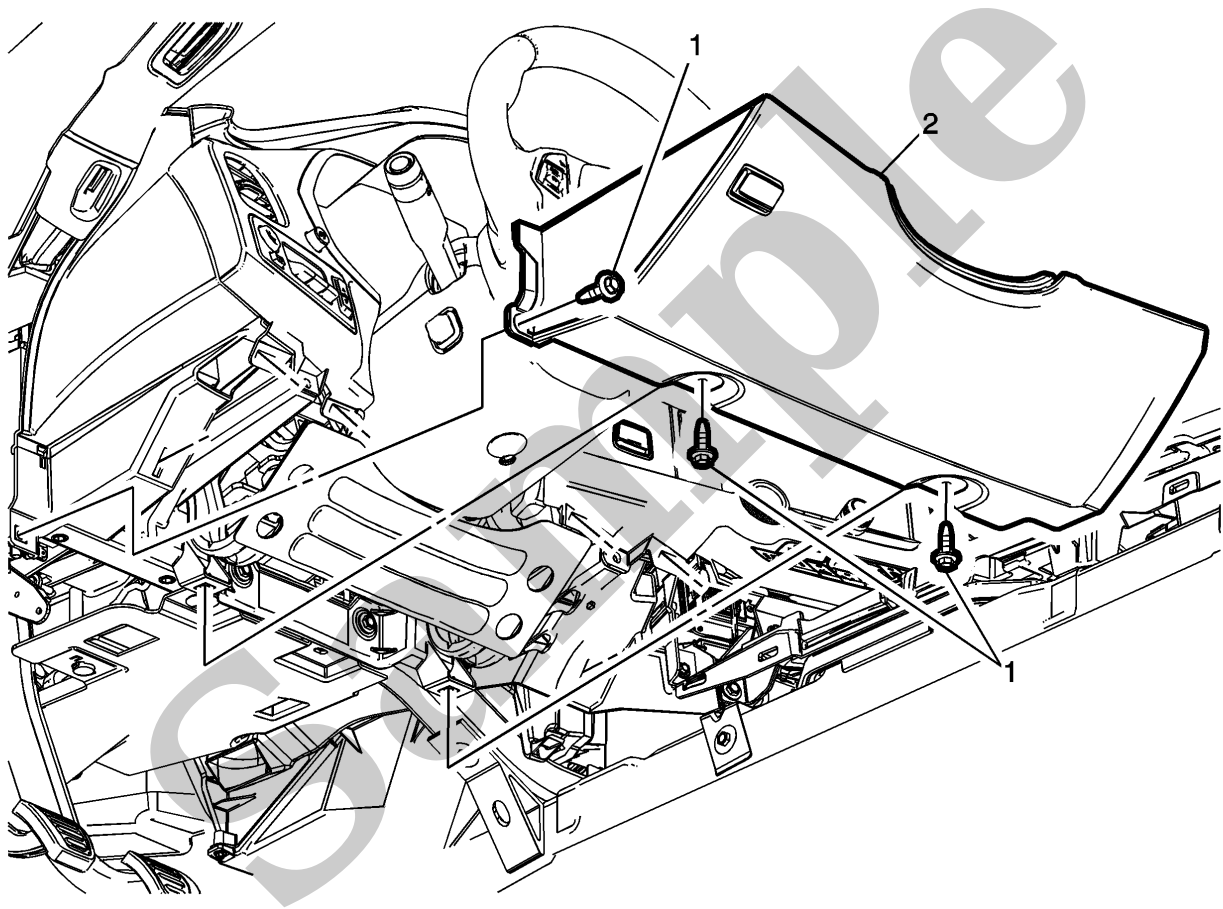
Instrument Panel Knee Bolster Replacement

Callout	Component Name
Preliminary Procedure	
1. Remove the left front floor console trim plate. Refer to Front Floor Console Trim Plate Replacement	
2. Remove the left front side door sill garnish molding. Refer to Front Side Door Sill Garnish Molding Replacement .

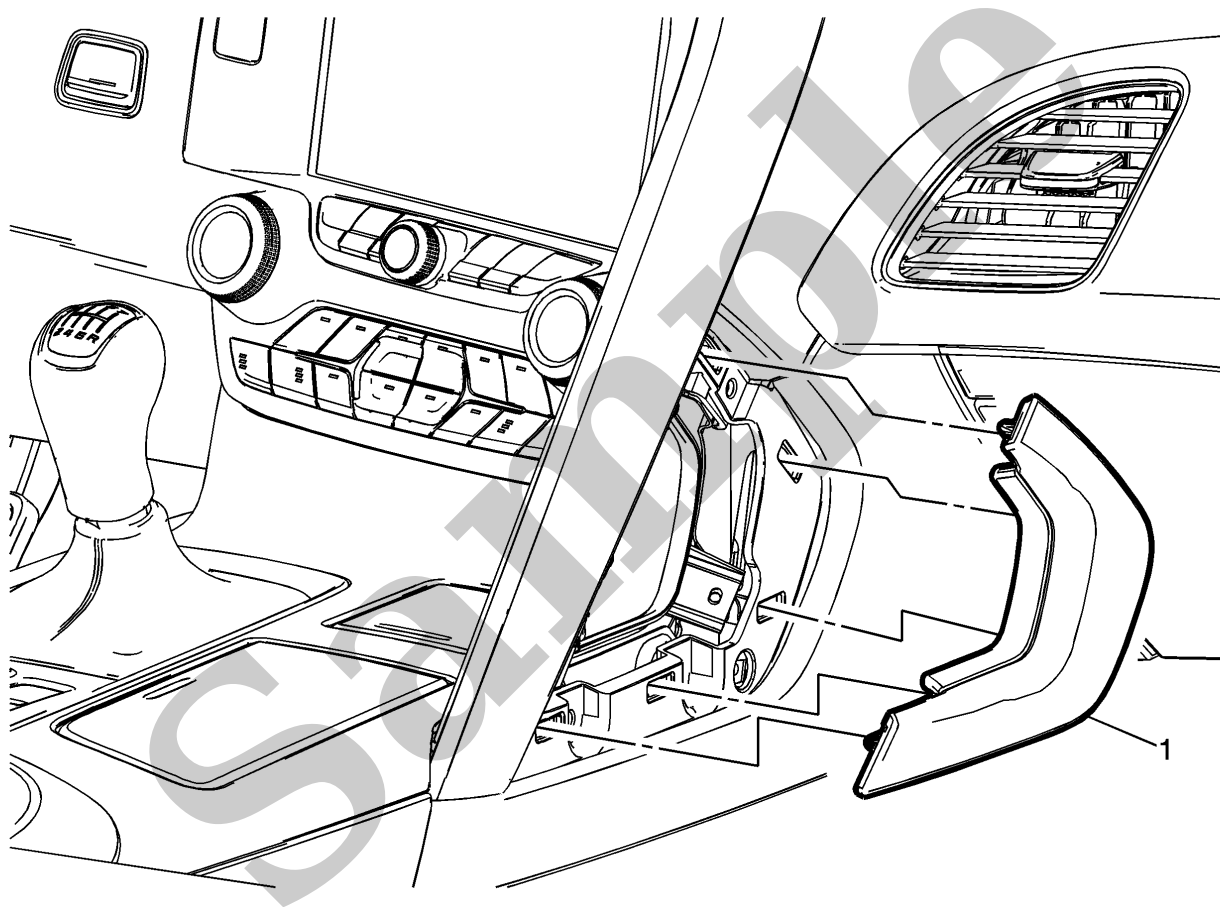
Instrument Panel Lower Center Trim Panel Replacement

Callout	Component Name
Preliminary Procedure Remove the right instrument panel assist handle. Refer to Instrument Panel Assist Handle Replacement .	
1	Instrument Panel Lower Center Trim Panel Procedure

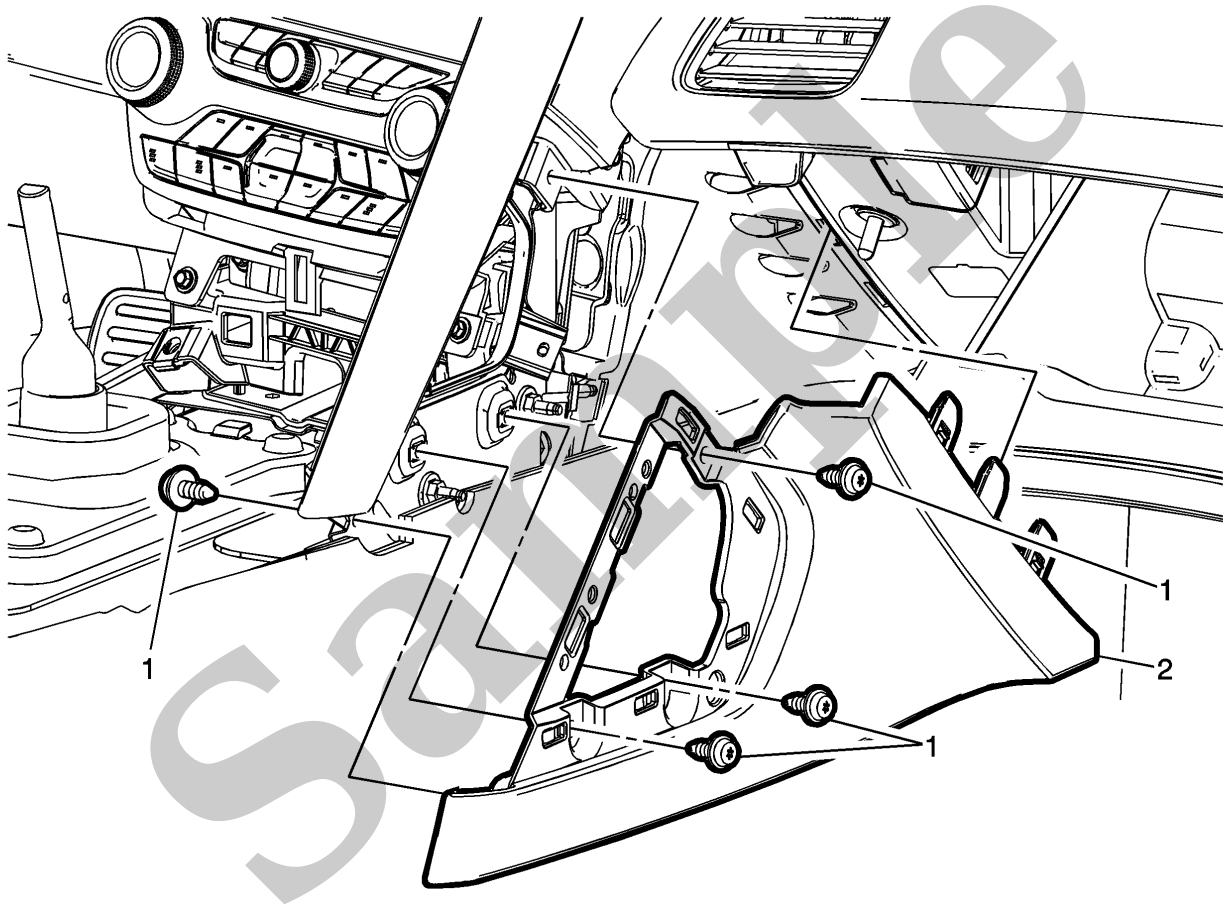
Instrument Panel Lower Trim Panel Replacement

Callout	Component Name
Preliminary Procedures	
1.	Remove the instrument panel lower center trim panel. Refer to Instrument Panel Lower Center Trim Panel Replacement .
2.	Remove the front floor lower console. Refer to Front Floor Lower Console Replacement .

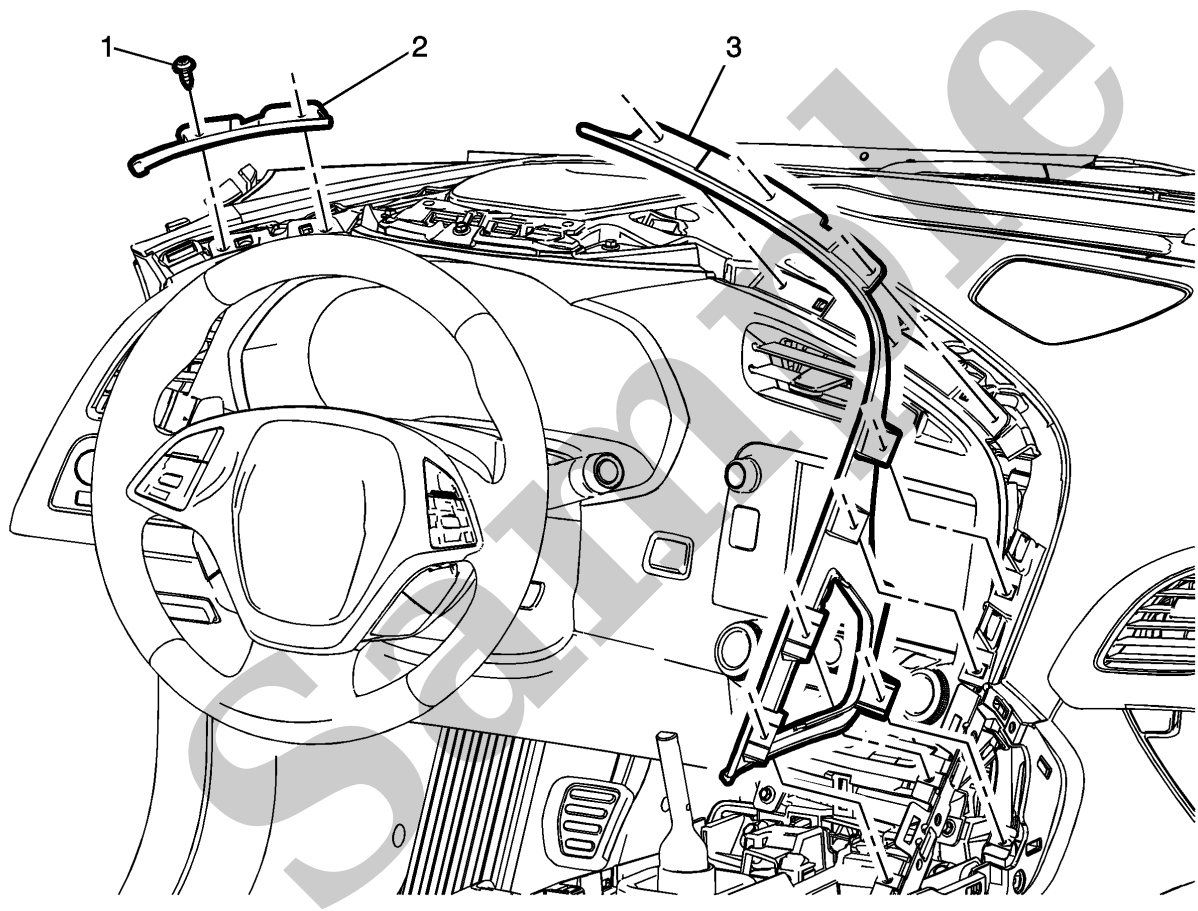
Instrument Panel Molding Replacement

Callout	Component Name
<p>Preliminary Procedure</p> <p>1. Remove the instrument panel center upper molding. Refer to Instrument Panel Center Upper Molding Replacement.</p> <p>2. Remove the instrument panel lower center trim panel. Refer to Instrument Panel Lower Center Trim Panel Replacement.</p>
