2011 FORD Mustang Shelby GT500 OEM Service and Repair Workshop Manual

Automotive Audio Bus (AAB) Cable - Vehicles With: 8 Inch Center Display Screen/12 Inch Center Display Screen

415-00 Information and Entertainment System - General Information	2022 F-150
Removal and Installation	Procedure revision date: 03/29/2022

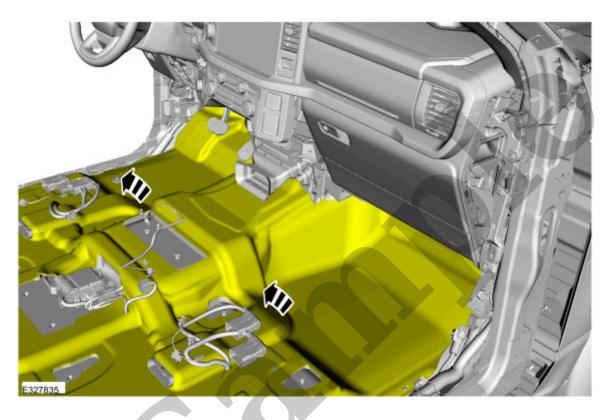
26. Fold the carpet rearward.

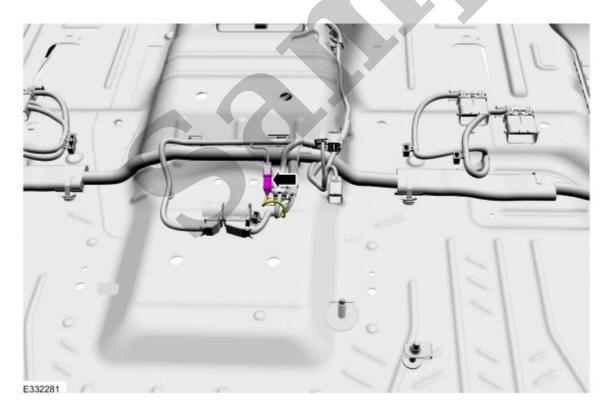
29. Disconnect the body harness AAB (automotive audio bus) front connector.

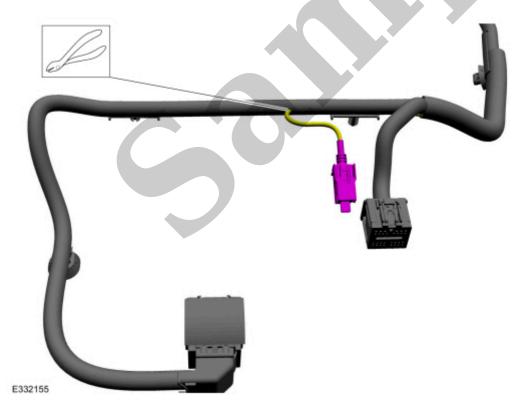
2. Cut the lower connector end off the cable where it enters the instrument panel harness.

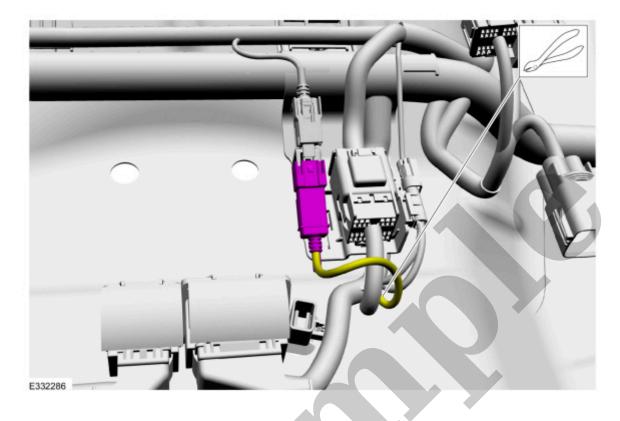
4. Cut the front connector end off the cable where it enters the body harness.

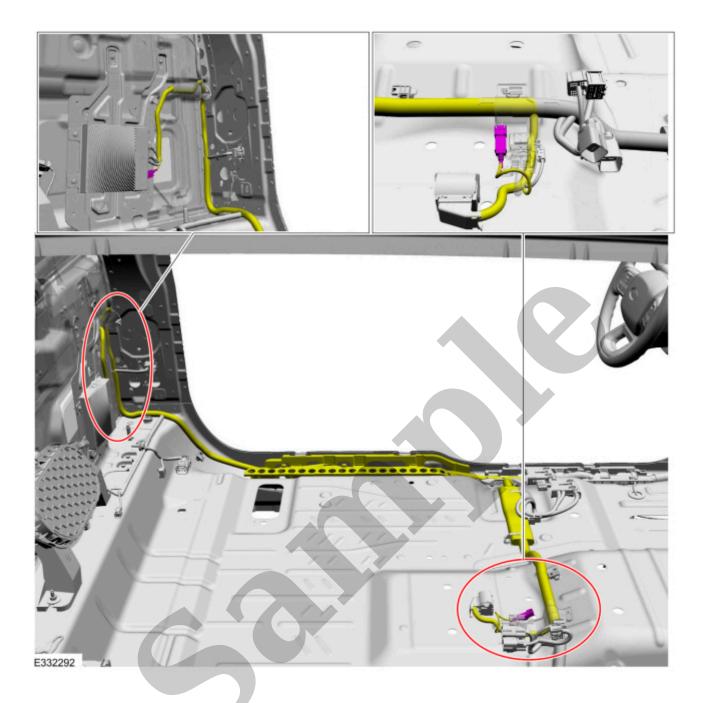
Eight speaker system DSP (audio digital signal processing module) is shown, 18 speaker system DSP (audio digital signal processing module) is similar.

Cut the rear connector end off the cable where it enters the body harness.

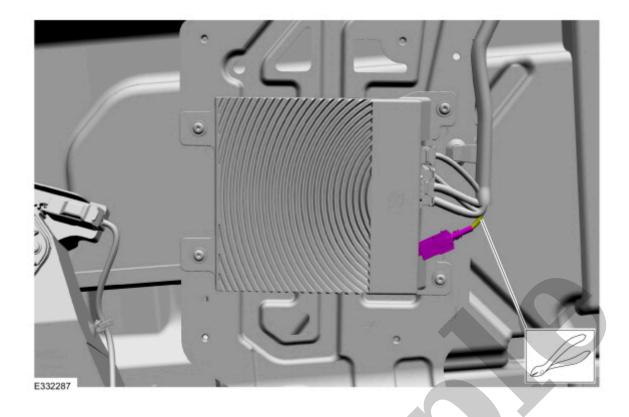
7. Cut the front connector end off the cable where it enters the body harness.

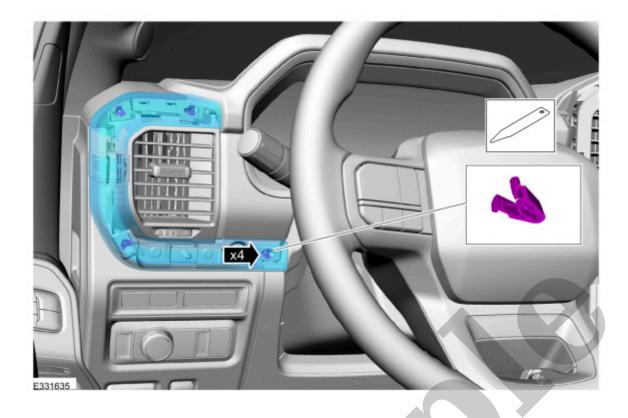
- 5. Remove the steering column opening lower trim panel.
 - 1. Unclip and lower the steering column opening lower trim panel.
 - 2. Remove the retainers and the steering column opening lower trim panel.

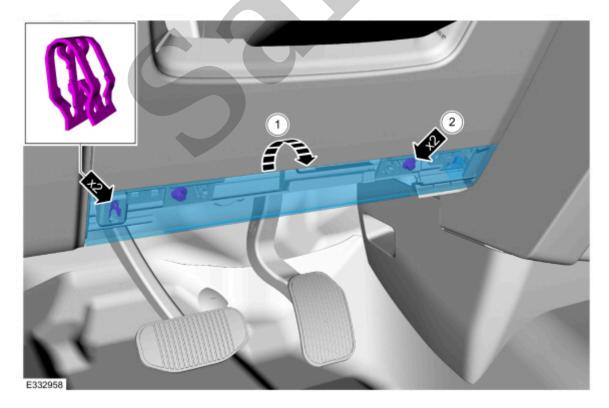
8. Release the tabs and disconnect the gap hider from the upper steering column shroud.

Use the General Equipment: Interior Trim Remover
