2023 Toyota Corolla Service and Repair Manual

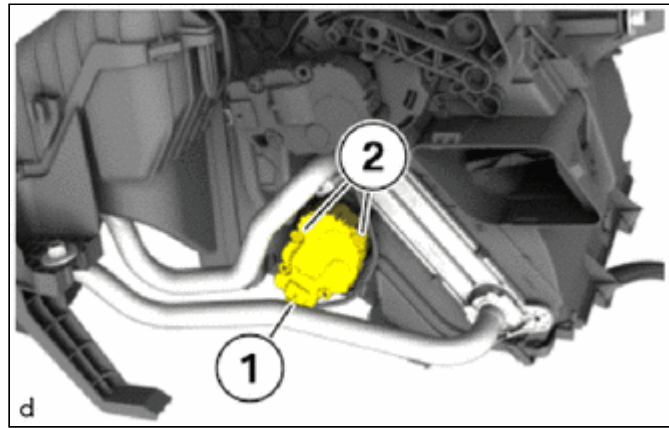
(a) Disconnect the connector (1).

(b) Remove T20 screws (2).

(c) Remove No. 1 air conditioning radiator damper servo sub-assembly (M23a).

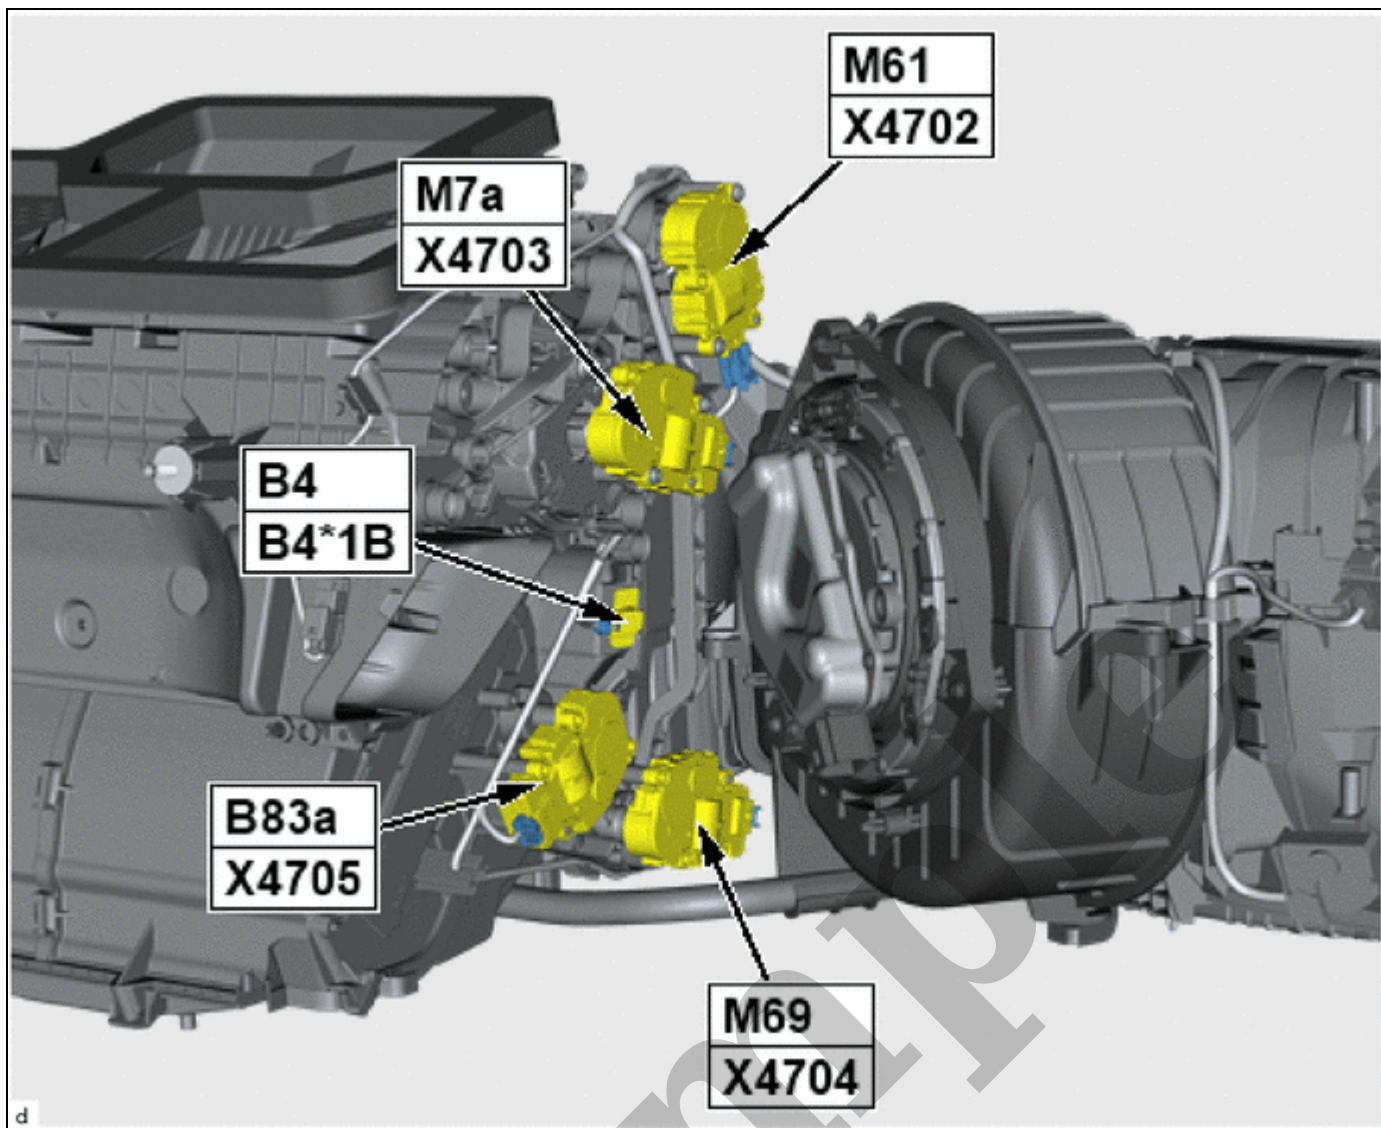
16. REMOVE NO. 1 AIR CONDITIONING RADIATOR DAMPER SERVO SUB-ASSEMBLY (M83a)

Overview of No. 1 air conditioning radiator damper servo sub-assembly of air conditioning unit assembly:

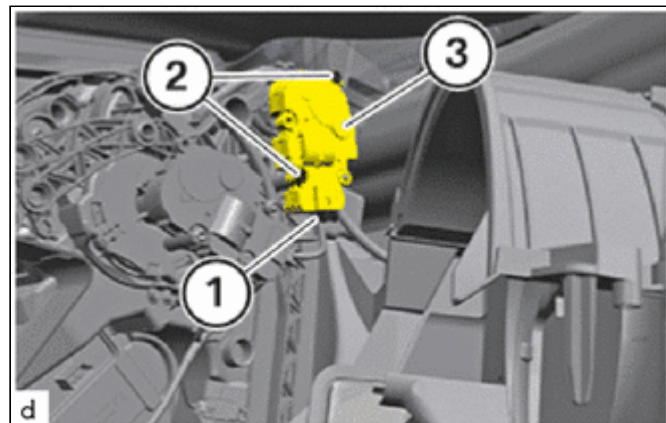
(a) Disconnect the connector (1).

(b) Remove T20 screws (2).

(c) Remove No. 1 air conditioning radiator damper servo sub-assembly (M61) (3).

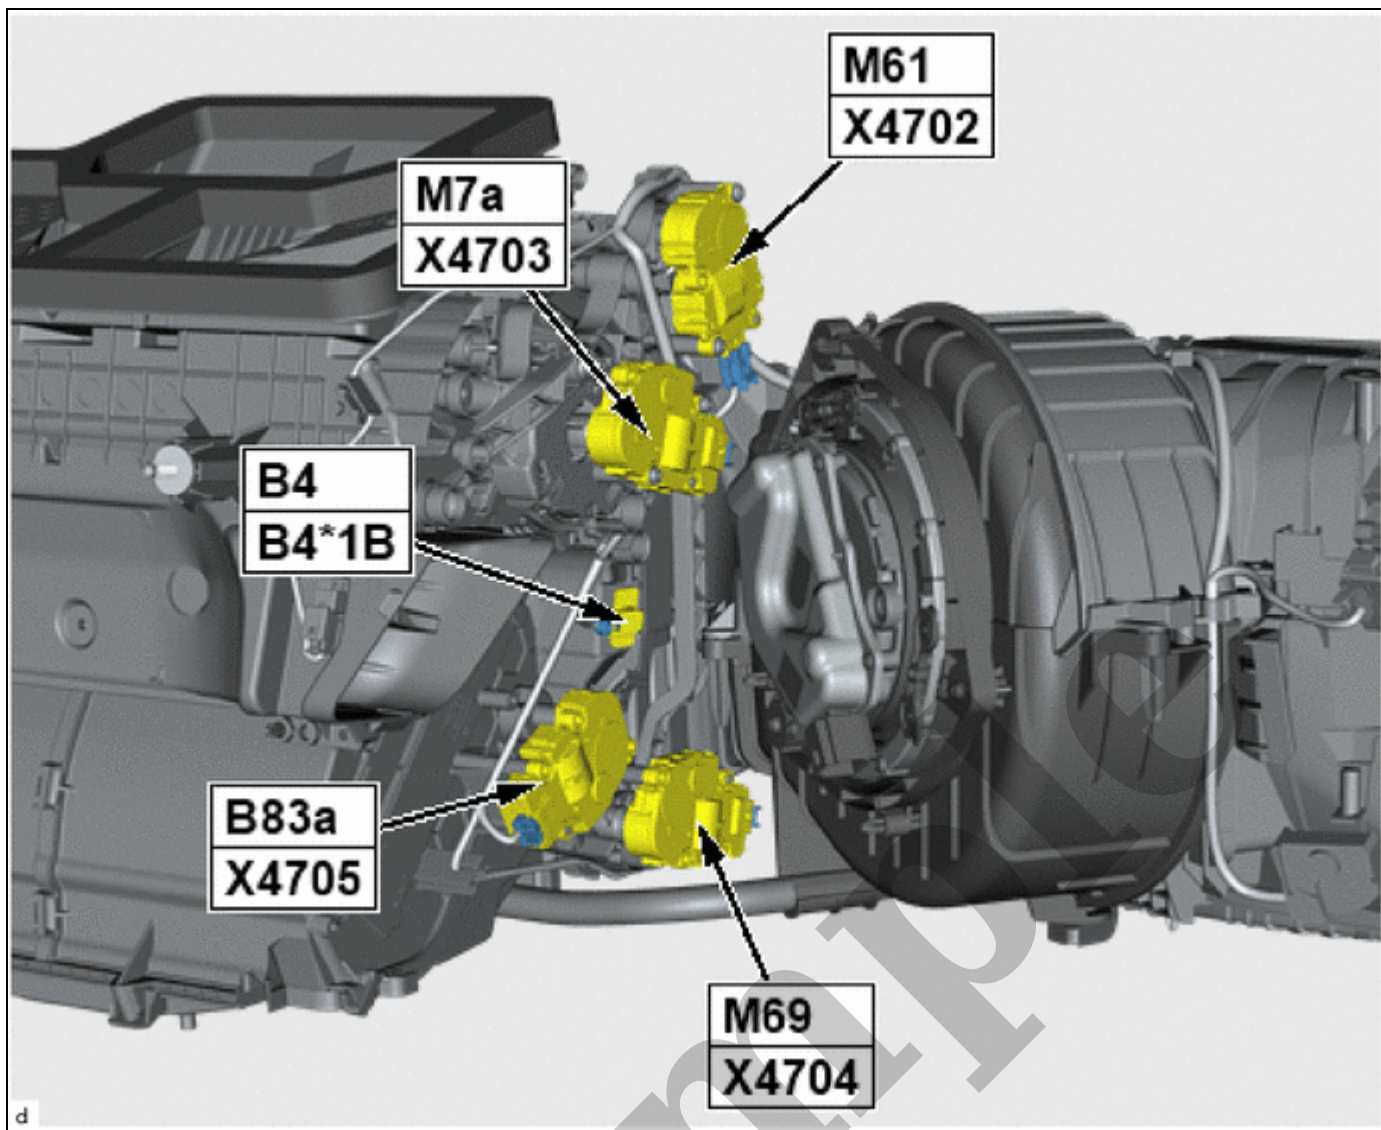
19. REMOVE NO. 1 AIR CONDITIONING RADIATOR DAMPER SERVO SUB-ASSEMBLY (M7a)

Overview of No. 1 air conditioning radiator damper servo sub-assembly of air conditioning unit assembly:

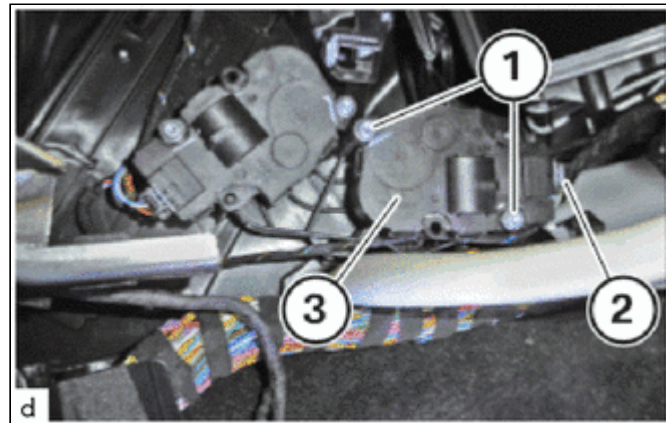
(a) Disconnect the connector (2).

(b) Remove T20 screws (1).

(c) Remove No. 1 air conditioning radiator damper servo sub-assembly (M69) (3).

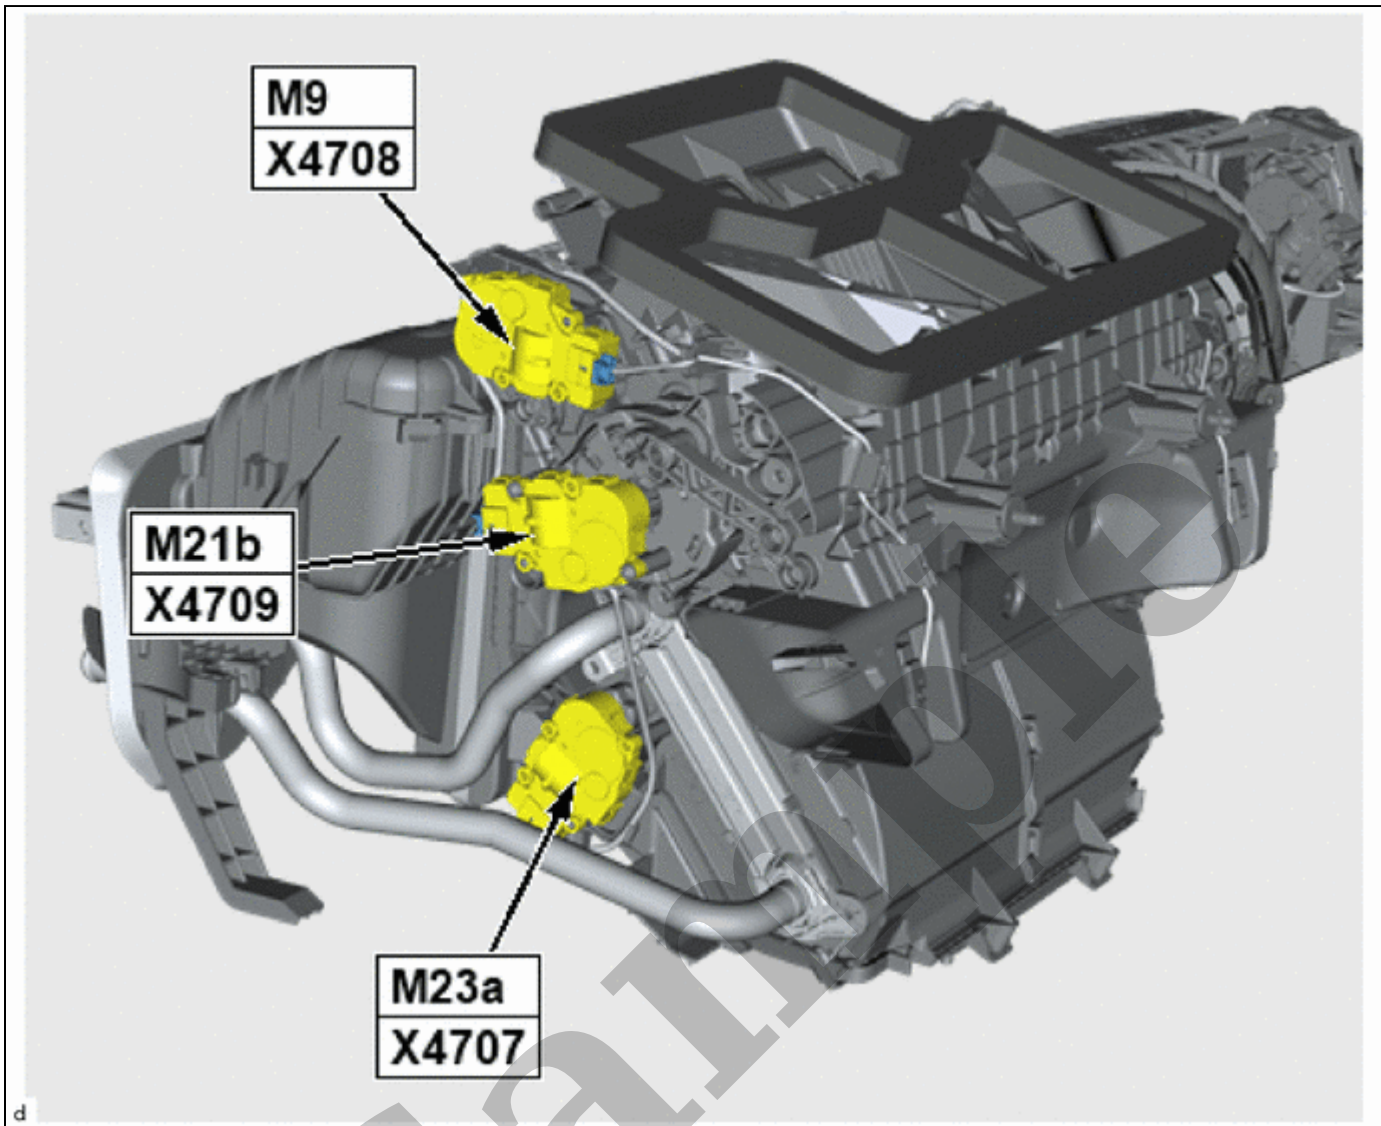
25. REMOVE NO. 1 AIR CONDITIONING RADIATOR DAMPER SERVO SUB-ASSEMBLY (M21b)

Overview of No. 1 air conditioning radiator damper servo sub-assembly of air conditioning unit assembly:

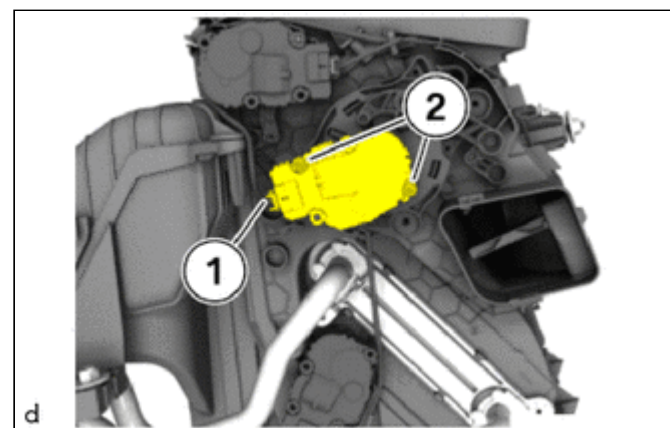
(a) Disconnect the connector (1).

(b) Remove T20 screws (2).

(c) Remove No. 1 air conditioning radiator damper servo sub-assembly (M21b).
